# DIAGNOSIS BY ULTRASOUND OF RUPTURE OF MAMMARY IMPLANTS AND OTHER ASSOCIATED COMPLICATIONS: REVISION ARTICLE

## DIAGNÓSTICO POR ECOGRAFÍA DE RUPTURA DE IMPLANTES MAMARIOS Y OTRAS COMPLICACIONES ASOCIADAS: ARTÍCULO DE REVISIÓN

Michel Hernández Restrepo<sup>1</sup>  
Fredy Martín Cerquera Cabrera<sup>2</sup>  
Jaime A. Ortega Santamaría<sup>1</sup>

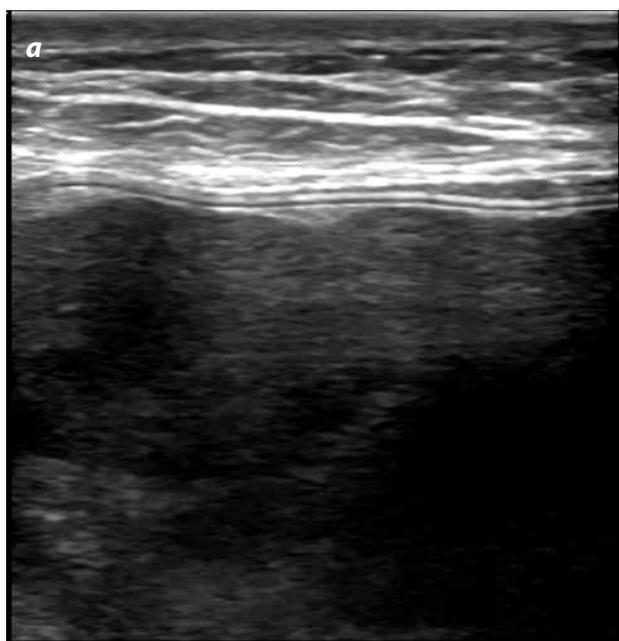
Figure 8. Mammary ultrasound with a high-frequency lineal transducer: (a) Complicated internal appearance due to multiple echoes in the lumen of the prosthesis. This finding is compatible with intra-capsular rupture (b, c). Gel which is extravasated in the space between the crease of the external cover of the prosthesis and the fibrotic external capsule is found. This finding is related to extra-capsular rupture.

In the intra-capsular rupture, the gel is extravasated to the space between the fibrotic capsule and the external cover of the implant, giving way to an anomalous widening of the space between the capsule and the cover (figure 8) (finding which leads to the "ladder" sign in the ultrasound, or "linguini" or "sub-capsular line" in the resonance and in the ultrasound, which is the final stage) (24,31-33).

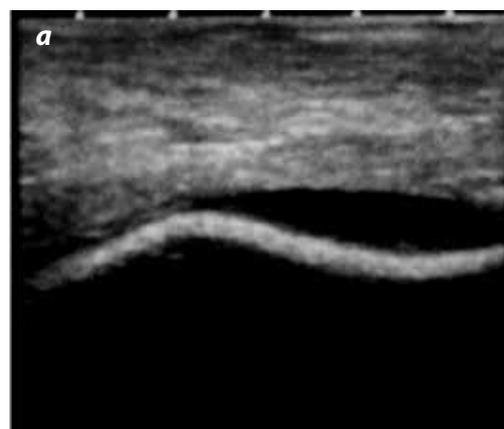
Figure 12. Seromas after a recent implant. Mammary ultrasounds with high-frequency lineal transducer. (a) Limited anechoic peri-implant effusion can be seen in a patient without other rupture findings. (b) Small quantity of anechoic liquid anterior to the fibrotic external capsule related to a seroma and an edema of the associated subcutaneous cellular tissue; these findings were observed in patients with a short implant evolution time, who did not present signs which could suggest rupture.
